**LIMITED LEAD BASED PAINT (LBP) SURVEY  
FOR THE  
SUSPECT COATINGS ASSOCIATED WITH THE STEEL BARREL ROOF  
STRUCTURES FOR HANGERS 1 AND 3 OF BUILDING 2050  
LOCATED ON  
FAIRCHILD AFB, WA 99011**

**Project No: S08-006.32  
Control Number: CER-F082  
Call Number: 27**

*Prepared for:*  
**92<sup>ND</sup> CES/CEO**  
*100 W Ent Street, Suite 310  
Fairchild AFB, WA 99011-9688*

September 2, 2008

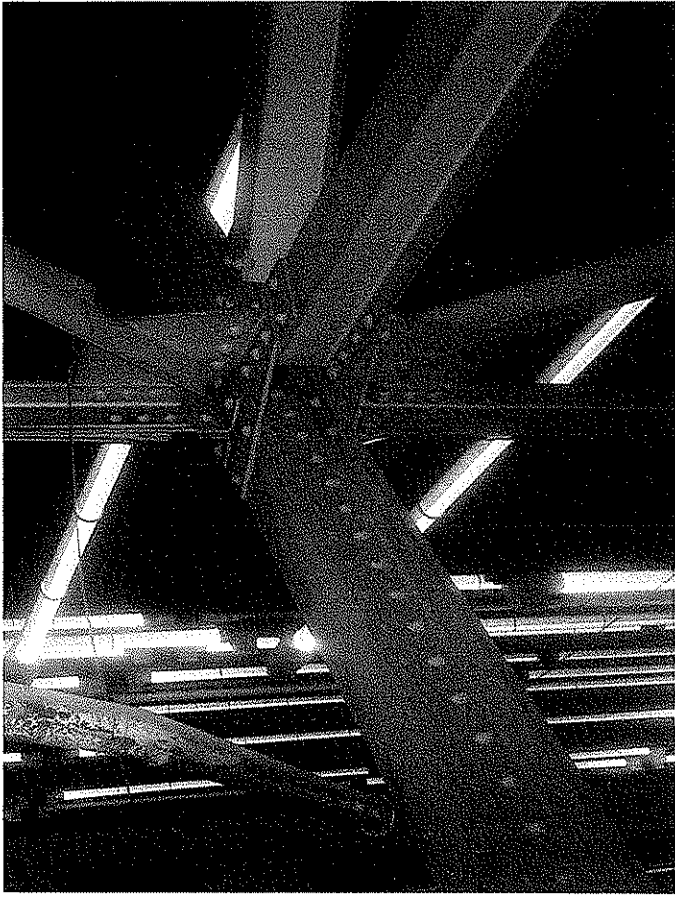
**METAL TRUSSES**

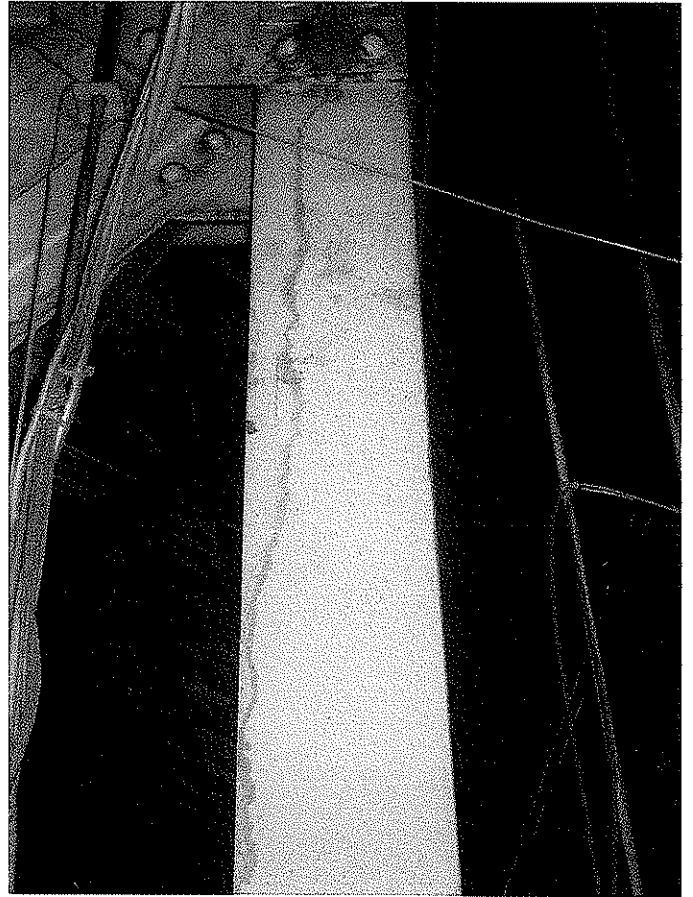
**METAL SUPPORT BEAMS SHOWING GREEN AND BROWN  
PAINT TESTED**
